# Dunlin Alpha Decommissioning

**Concrete Gravity Base  
In Situ Decommissioning  
Options for Derogation  
November 2011**

## In Situ Decommissioning Options for Derogation

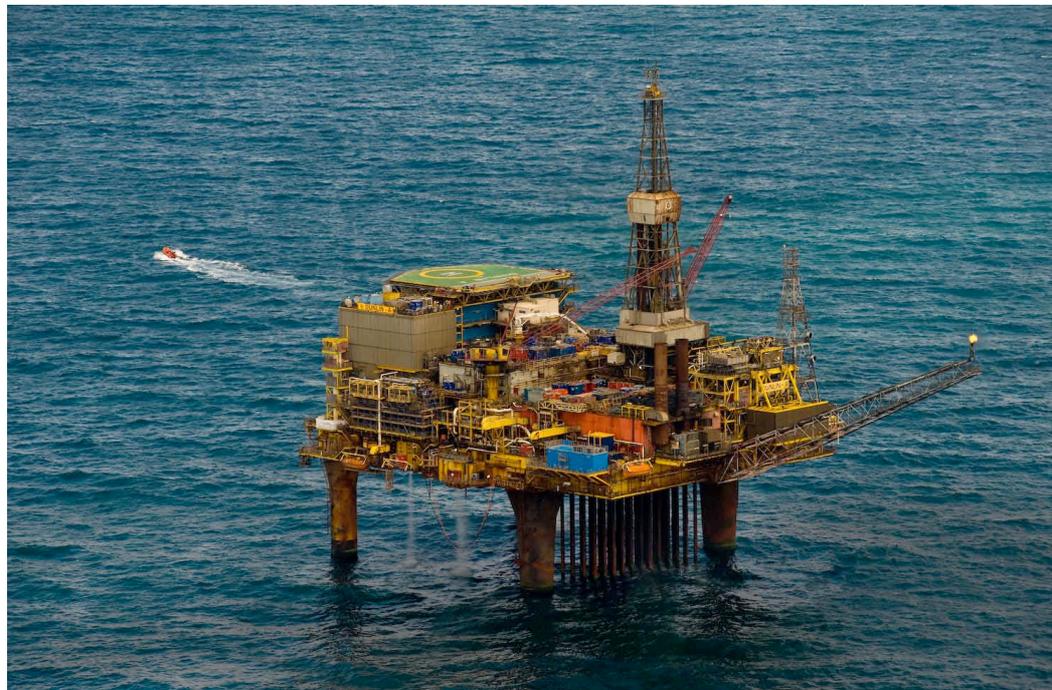
**Figure 2.1a Dunlin A platform**

The Dunlin Alpha platform, known as Dunlin A, came into operation in 1978 and acts as the production hub for the fields. Dunlin A is a concrete gravity base (CGB) structure supporting a steel topsides deck and production facilities, shown in Figure 2.1 below. Section 3 provides a brief description of the Dunlin A platform.

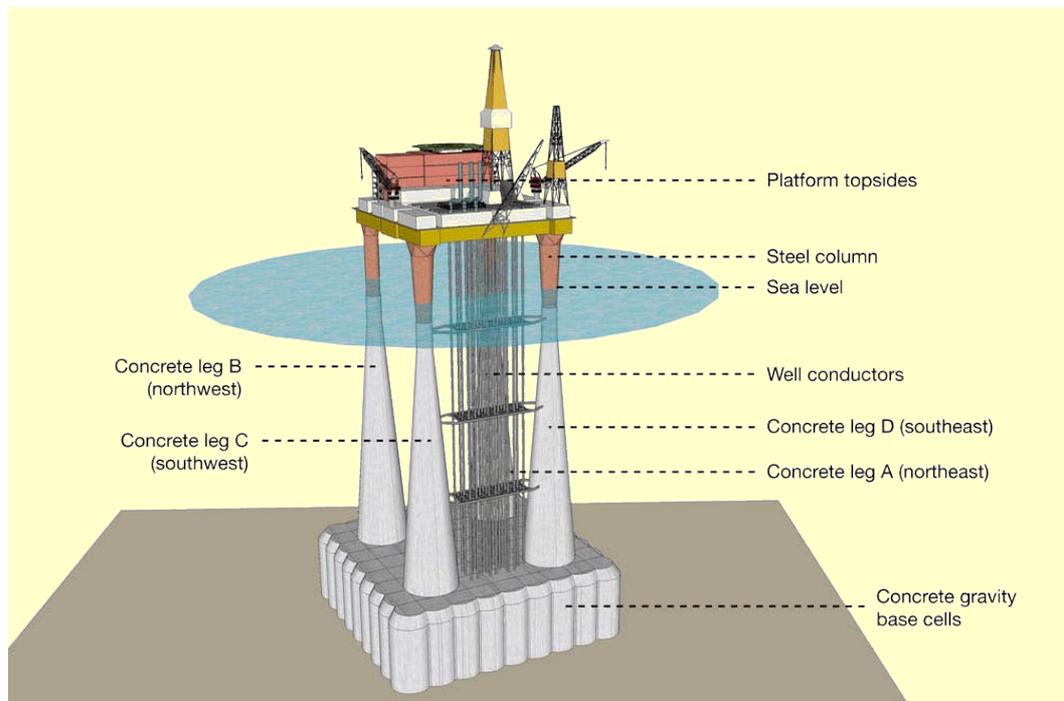
**Figure 3.1b Dunlin A platform main components**

Figure 3.1b below shows the main components of the platform.

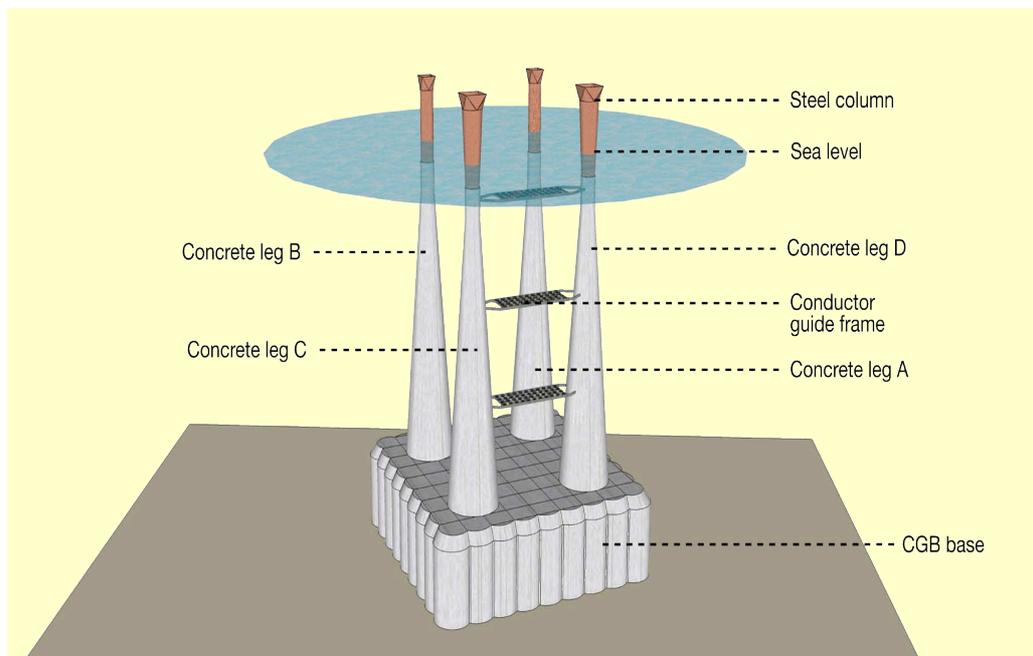
**Figure 3.2a CGB with topsides and conductors removed**

Rising up from the roof of the base cells are four reinforced concrete legs, each 111m high. These reduce in outside diameter from 22.6m at the bottom to 6.6m at the top, where they join the steel columns at 8m below sea level. The legs are designed as hollow shafts, with concrete walls generally being 700mm thick but increasing to 1200mm at the top and the bottom. Each of the concrete legs weighs approximately 7600 tonnes. See Figure 3.2a.

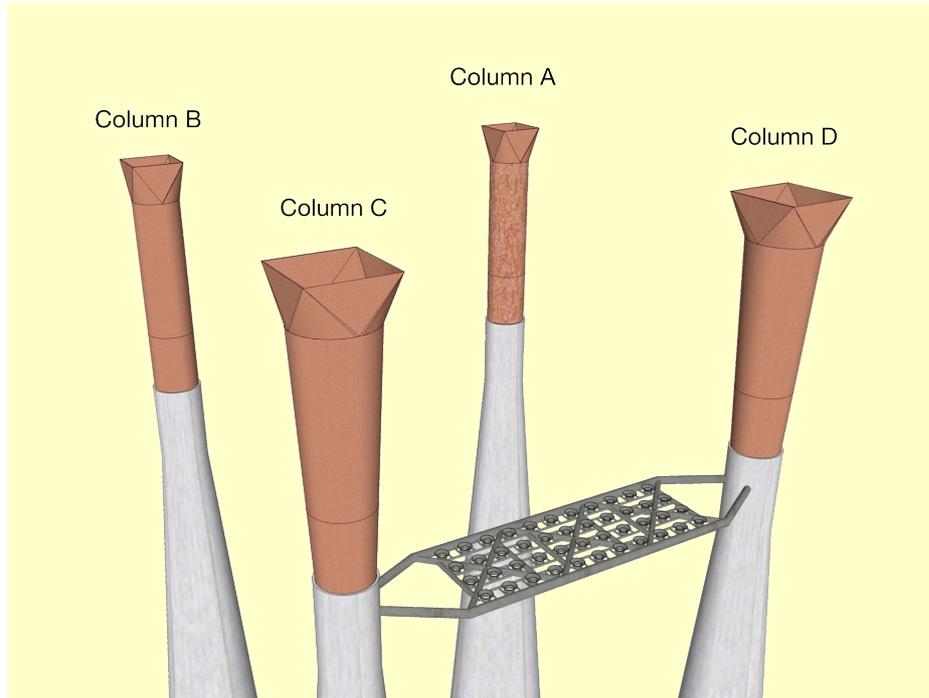
**Figure 3.2b Steel columns at the tops of the concrete legs**

Four steel columns constructed from stiffened steel plate extend 31m from the top of the concrete legs, rising beyond the sea surface to the underside of the topsides deck. These columns are bolted and grouted into the top of the concrete legs. The steel columns C and D weigh some 500 tonnes each and taper from approximately 6m diameter at the top of the concrete legs to approximately 8.7m square at the underside of the deck. The other two columns on Legs A and B weigh approximately 300 tonnes each and are 5.4m in diameter, changing to a square section at the deck underside. See Figure 3.2b below.

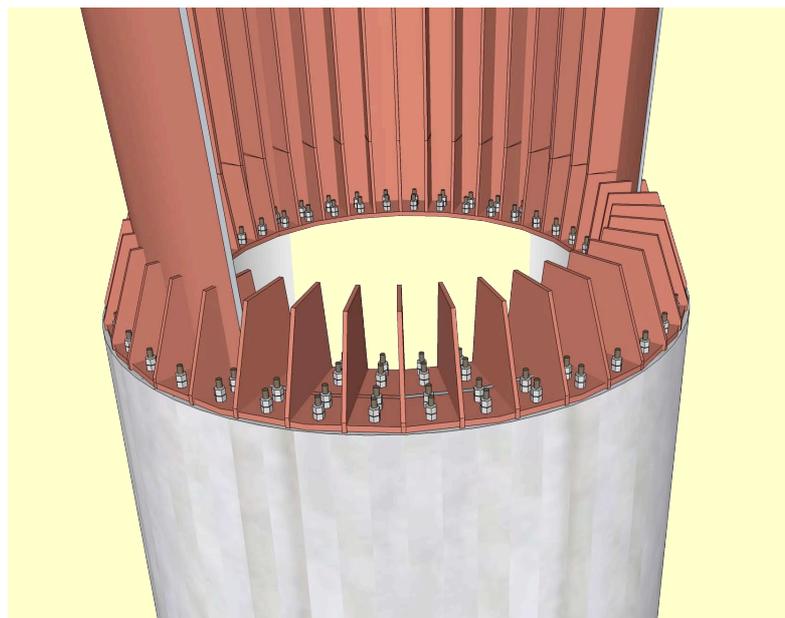
**Figure 3.2c. Bolted connection between concrete leg and steel column**

The Leg A and Leg B steel columns are connected to the concrete legs with one external row of 40 bolts, 50mm in diameter, plus two internal rows of 40 bolts of the same size (120 bolts in total per leg). The Leg C and Leg D steel columns are connected to the concrete towers with two external and two internal rows of bolts (160 bolts in total per leg). The bolted connection is shown in section in Figure 3.2c below.

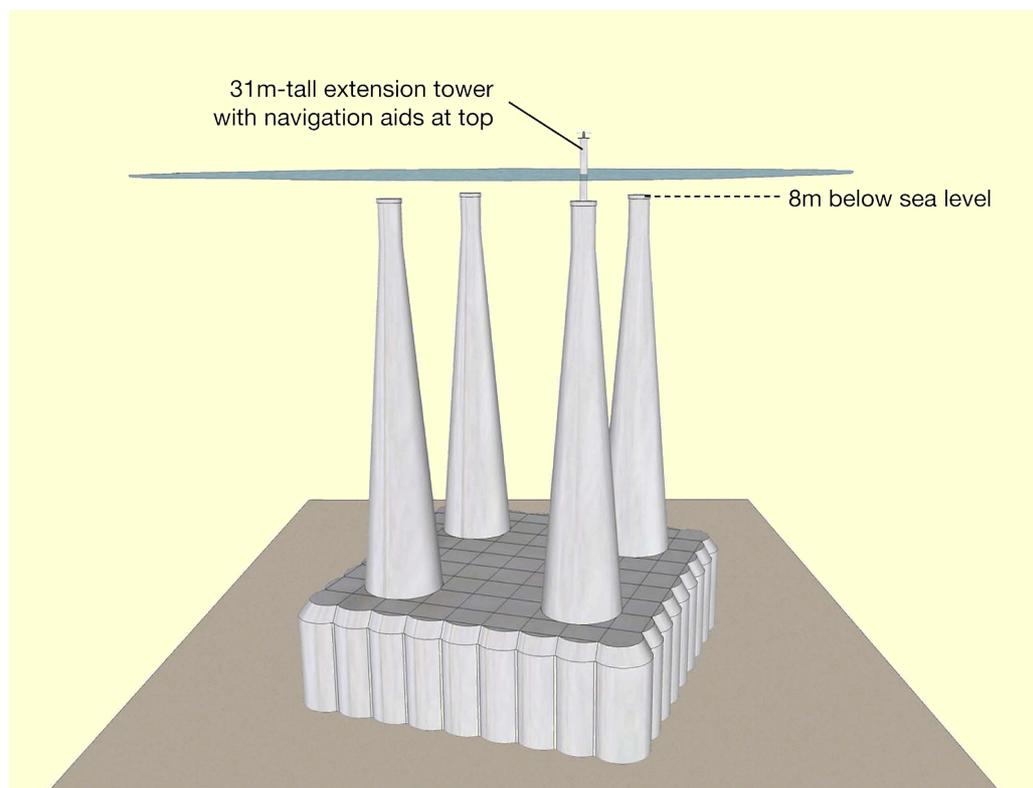
**Figure 4.1a. CGB left wholly in place and marked with navigation aids**

The steel columns, conductor guide frames and all external steelwork would be removed. The remaining concrete structure would be entirely submerged with 8m water cover at low tide. As this would not comply with IMO guidance for providing 55m of clear water above the CGB, it is proposed that a 31m-tall extension tower be installed on the top of one or more legs to carry navigation aids. The navigation lights would be located 23m above sea level, around the same level of the current Dunlin A navigation lights. The structure would be marked on relevant nautical charts and the 500m radius exclusion zone afforded to offshore oil and gas installations would be retained.

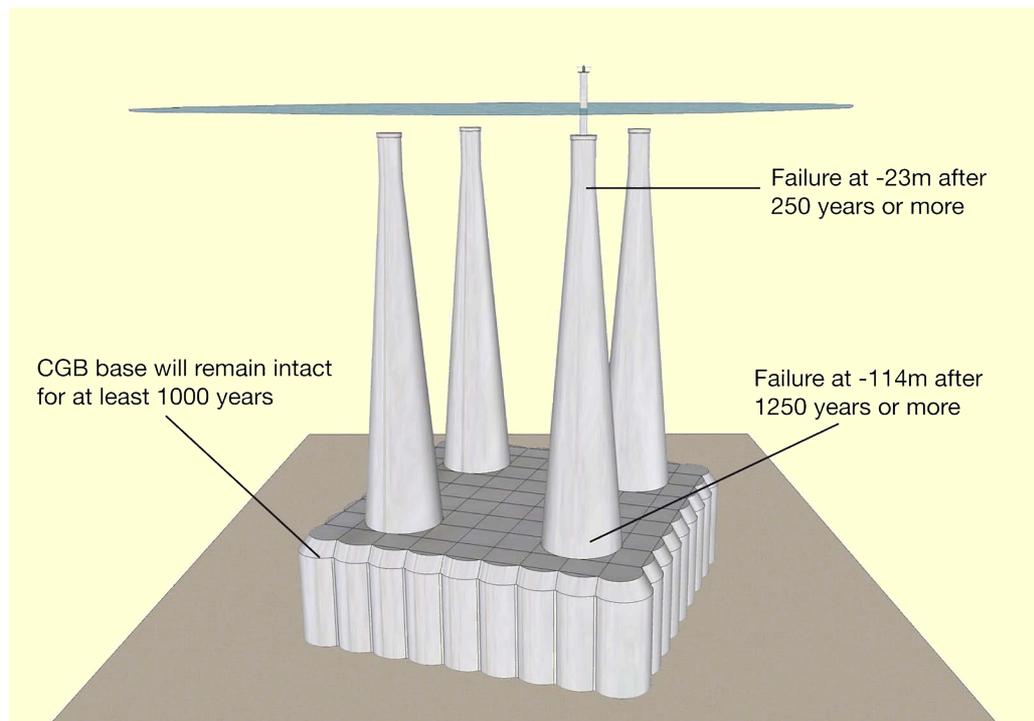
**Figure 4.1b. Predicted durations for concrete failure in the CGB**

Structural analysis of the submerged CGB conducted by Atkins concludes that with a navigation tower attached to a leg, it would be at least 250 years before the leg failed due to fatigue (see Appendix D). This is likely to occur some 23m below sea level at the conical to cylindrical section of the leg, where the leg cross section is at a minimum, as indicated in Figure 4.1b.

The legs not carrying navigation aids would also fail in this way over time. These legs would be subjected to lower environmental loading due to the absence of the navigation tower, hence their failure would occur significantly beyond 250 years.

In the event of a fatigue failure at around 23m below sea level in the leg carrying the navigation aids, the remainder of the leg would reach a height above 55m below sea level, and would therefore not comply with current IMO guidelines for minimum navigable water depth. The navigation aids would no longer be visible.

The expected life of the legs at lower levels would be significantly longer. At water depths greater than 20m the structure is not exposed to significant cyclic environmental loads, hence the ultimate structural failure mechanism for the lower leg sections would likely be due to concrete degradation and steel reinforcement corrosion. It is estimated that at a level some 5m above the base of the CGB (113m below sea level), leg failure would not occur for 1250 years or longer.

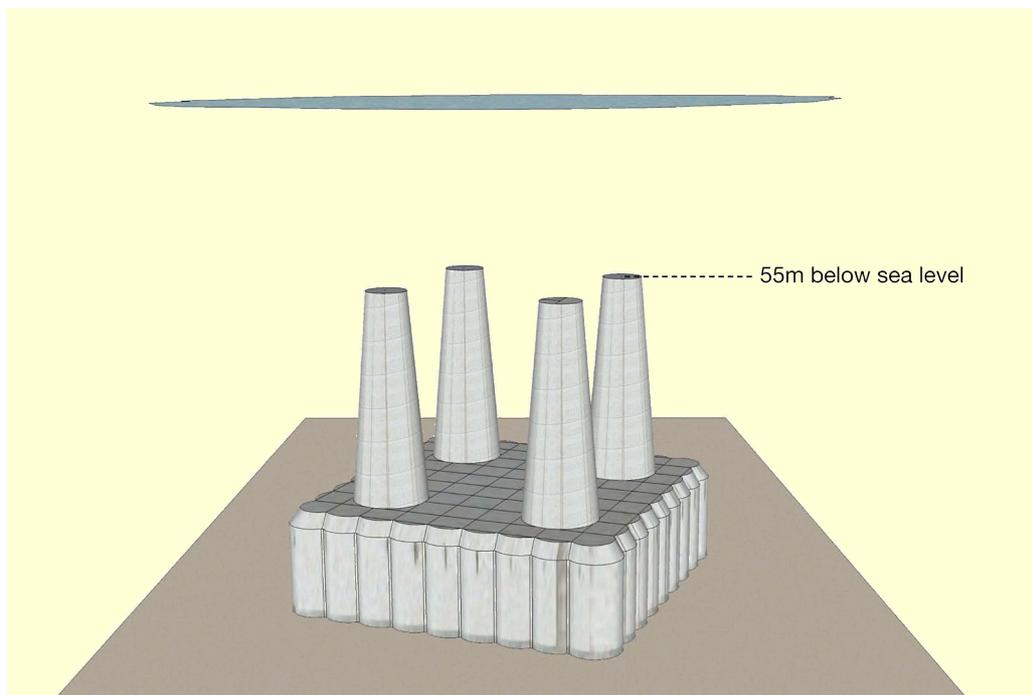
**Figure 4.2a. CGB left partly in place with legs cut at 55m below sea level**

For the first approach, it would be necessary to cut the concrete legs in a controlled stable operation, with the upper concrete sections, each weighing around 2600 tonnes, being attached to a heavy lift crane vessel in readiness for lifting from the sea. The result is shown conceptually in Figure 4.2a.

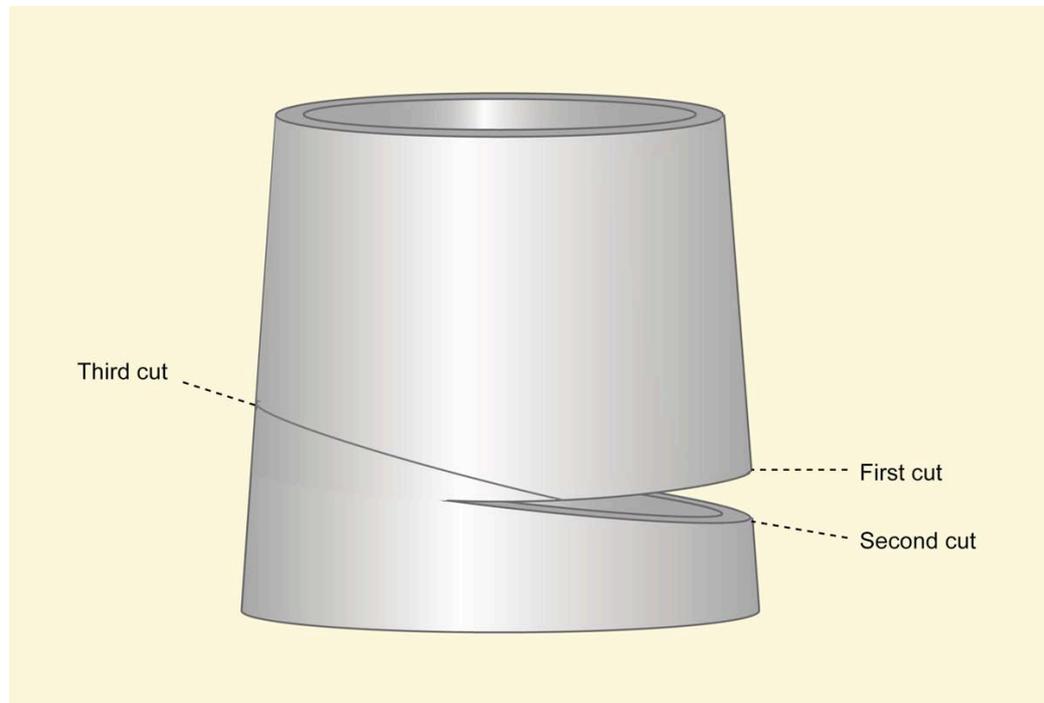
**Figure 4.2b. Conceptual cutting method for severing CGB leg.**

For the second approach of reducing the height of the CGB to 55m below sea level, a different method of removing the upper section of a leg might be considered in concept, referred to as ‘controlled demolition’. Instead of attempting to cut through the entire cross section of a leg prior to a crane lift, a break in the leg would be made by first removing a wedge shaped section of concrete, approximately 2m in height at its maximum, from one side of the leg. This could be achieved by making two cuts using diamond wire cutting technology arranged to cut through the thickness of the concrete wall without making contact with internal pipework and equipment. A third similar cut would then be made from the other side of the leg to intersect the created gap. This is shown conceptually in Figure 4.2b.

With the final cut almost complete, the upper leg section would be made to fall by surface tugs pulling it over. Alternatively, explosive charges might be used to induce structural failure and controlled demolition. With both methods the

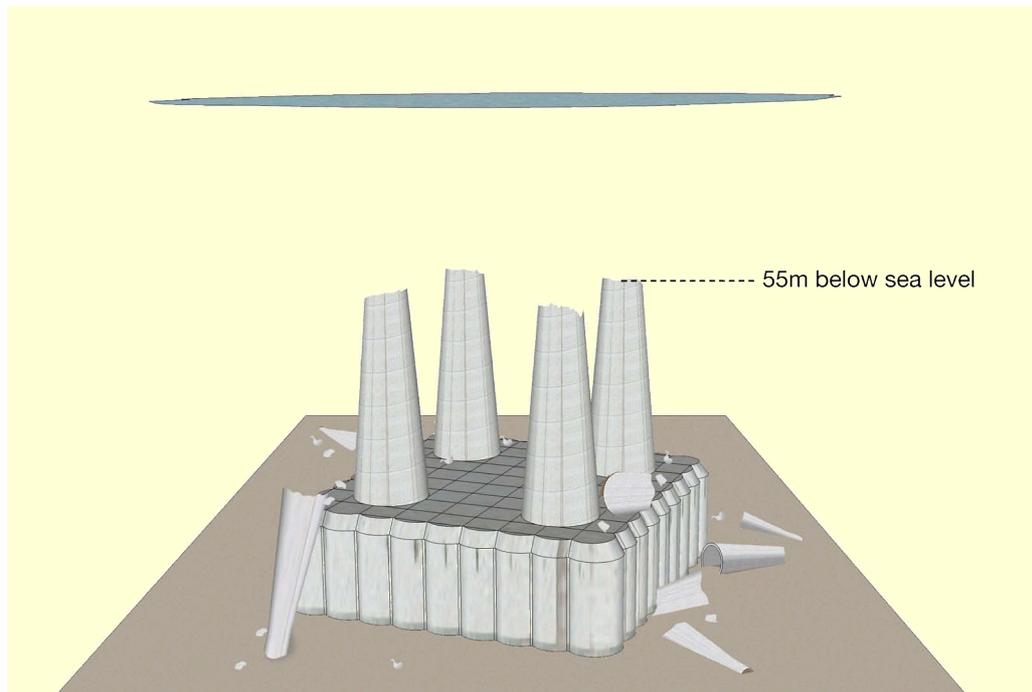
**Figure 4.2c. CGB left partly in place by controlled demolition of legs at 55m below sea level**

In these circumstances it would not be possible to predict with certainty how the upper section of a leg would fall from the 55m level and where it might land due to environmental loads acting on the upper section.. Furthermore, the impact of the leg sections on the base of the CGB and seabed would most likely cause the sections to fragment. The net result of this would be a structure terminating around 55m below sea level without being marked with navigation aids, with debris scattered on the seabed. This result is show conceptually in Figure 4.2c. (The severed pipework and steelwork is not shown on this diagram due to its small scale).

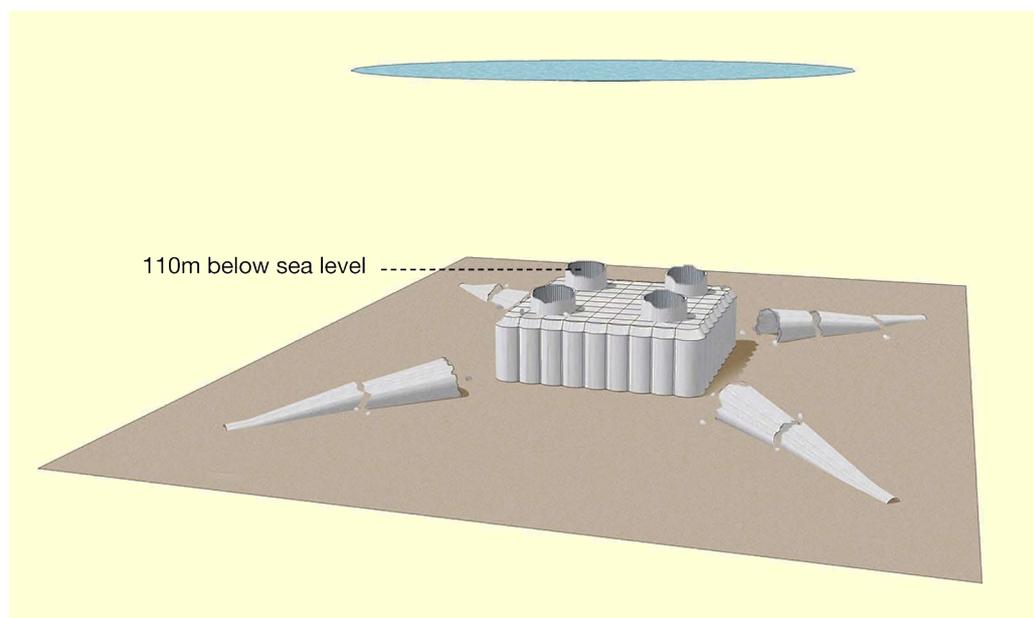
**Figure 4.3. CGB left partly in place by controlled demolition of legs at 110m below sea level**

To achieve this outcome, breaks would be made in the concrete legs in a similar way to that described in Section 4.2, by the controlled demolition method of first removing a wedge shaped section of concrete from one side of the leg using diamond wire cutting, and then cutting towards this from the other side. With the final cut almost complete, the upper leg section would be made to fall by surface tugs pulling it over. Alternatively, explosive charges might be used to induce structural failure and controlled demolition. With both methods the internal steel and pipework in the legs would be bent and sheared by the falling upper leg section.

The direction of fall of the leg sections would be more predictable when cut at this lower level, but they would most likely fragment when they reached the seabed, as shown conceptually in Figure 4.3. (The severed pipework and steelwork is not shown on this diagram due to its small scale).

In this condition the remaining structure would not be exposed to significant cyclic environmental loads and the ultimate failure of the structure would likely result from concrete degradation and the corrosion of reinforcing steel. As stated in Section 4.2, it is anticipated that complete collapse of the CGB base structure would not occur for at least 1000 years.

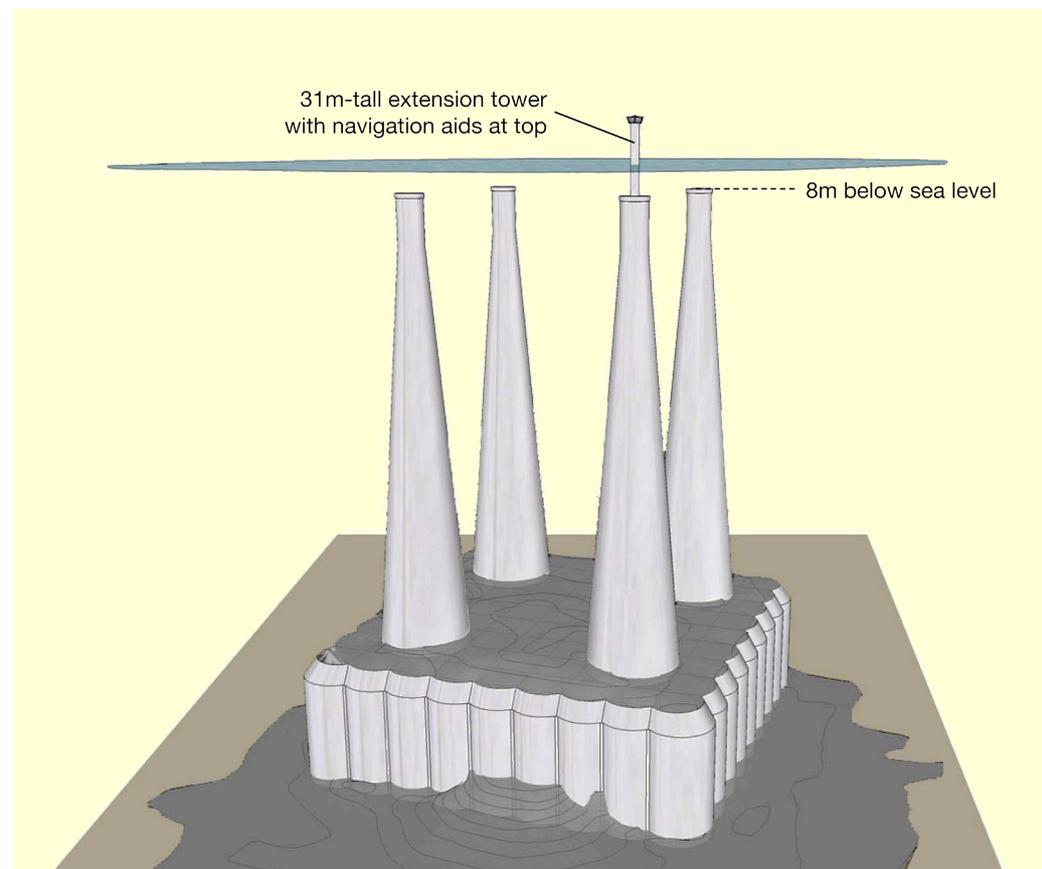
**Figure 6.1. CGB decommissioned at 8m below sea level, fitted with navigation aids on one leg**

Therefore, Fairfield Energy concludes that the only viable derogation option for the Dunlin A CGB is to leave the structure wholly in place, submerged to 8m below sea level, with the installation of one or more leg extensions reaching above the sea surface to support navigation lights, as may be required by the Northern Lighthouse Board. This outcome is shown conceptually in Figure 6.1, with drill cuttings shown.

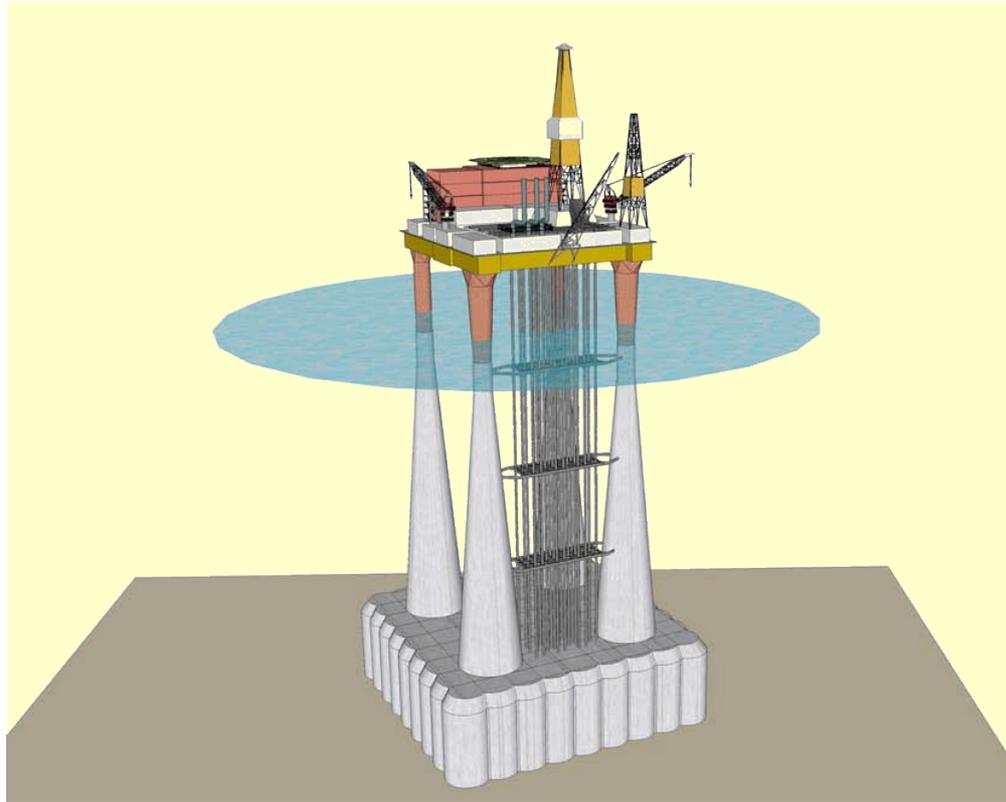
**Figure A.1c Dunlin A platform**

The Dunlin A platform, located in 151m of water, consists of a four-legged concrete gravity base (CGB) substructure with topsides supported by a steel box girder frame, as shown in Figure A.1c.

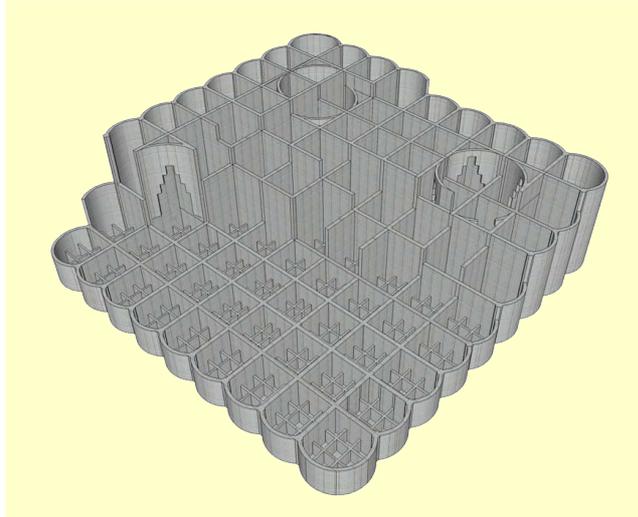
**Figure 4.2a Cells in the CGB (cutaway view)**

The base of the CGB, which is 32m high, is divided into 81 compartments, referred to as cells, arranged in a 9 x 9 matrix as shown in Figure 4.2a.

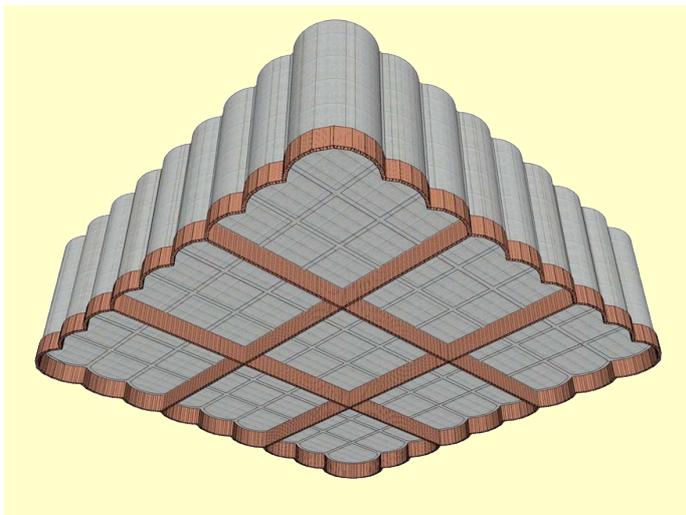
**Figure 4.2b Steel skirt and walls**

A stiffened steel plate wall runs around the perimeter of the base to form a skirt, and penetrates the seabed to a depth of 4m. Two further steel walls run underneath the base slab of the CGB in each direction, creating nine sub-base compartments. See Figure 4.2b below.

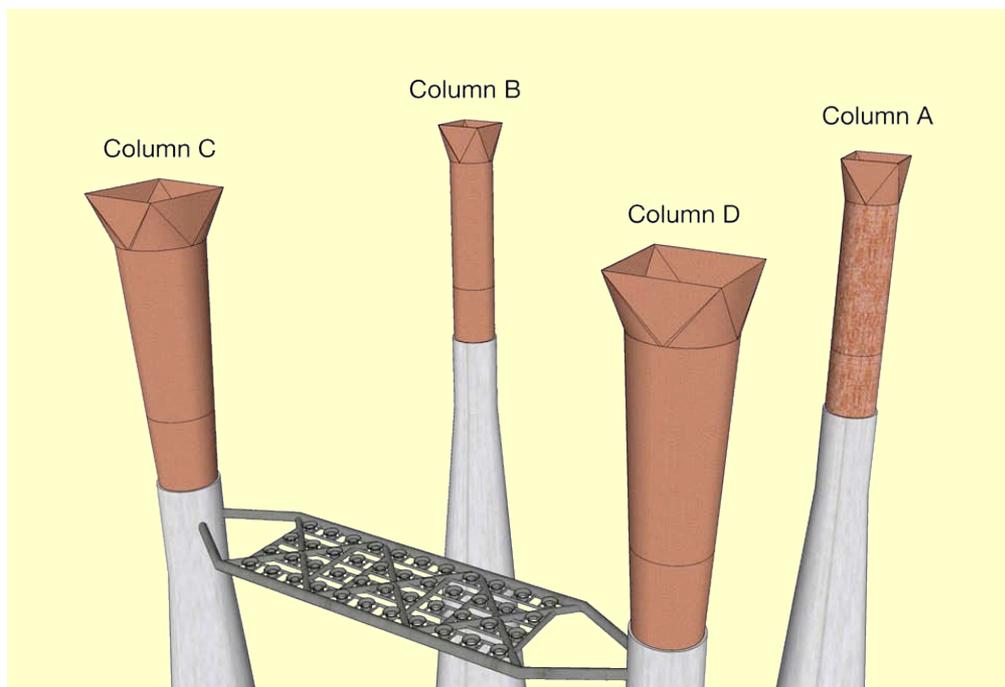
**Figure 4.2c Steel columns at the tops of the concrete legs**

Four steel columns constructed from stiffened steel plate extend 31m from the top of the concrete legs, rising beyond the sea surface to the underside of the topsides deck. These columns are bolted and grouted into the top of the concrete legs. The steel columns C and D weigh some 500 tonnes each and taper from approximately 6m diameter at the top of the concrete legs to approximately 8.7m square at the underside of the deck. The other two columns (Legs A and B) weigh approximately 300 tonnes each and are 5.4m diameter changing to a square section at the deck underside. See Figure 4.2c below.

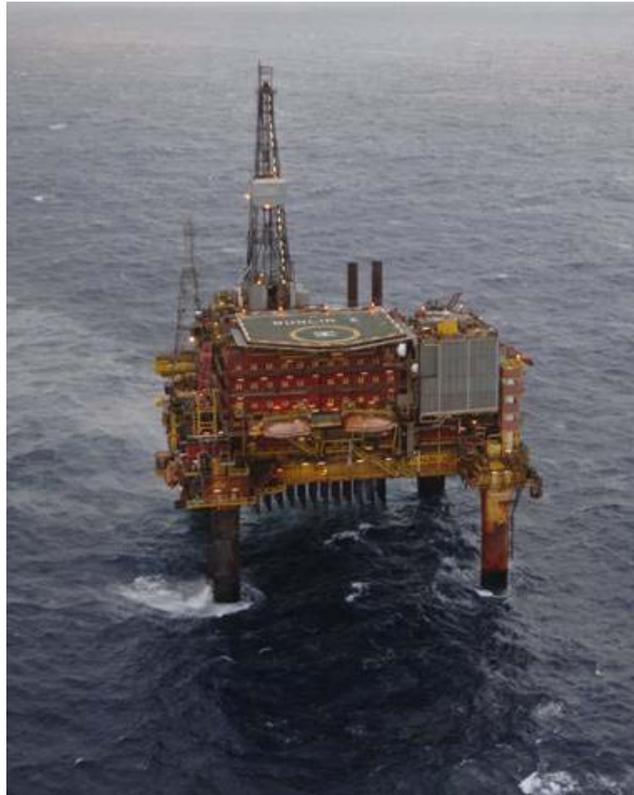
**Figure 1 : Dunlin Alpha**

Fairfield Energy (Fairfield) is operator of the Dunlin Cluster of fields in the UK sector of the North Sea, which includes the Dunlin Alpha concrete gravity base (CGB) platform (Figure 1).

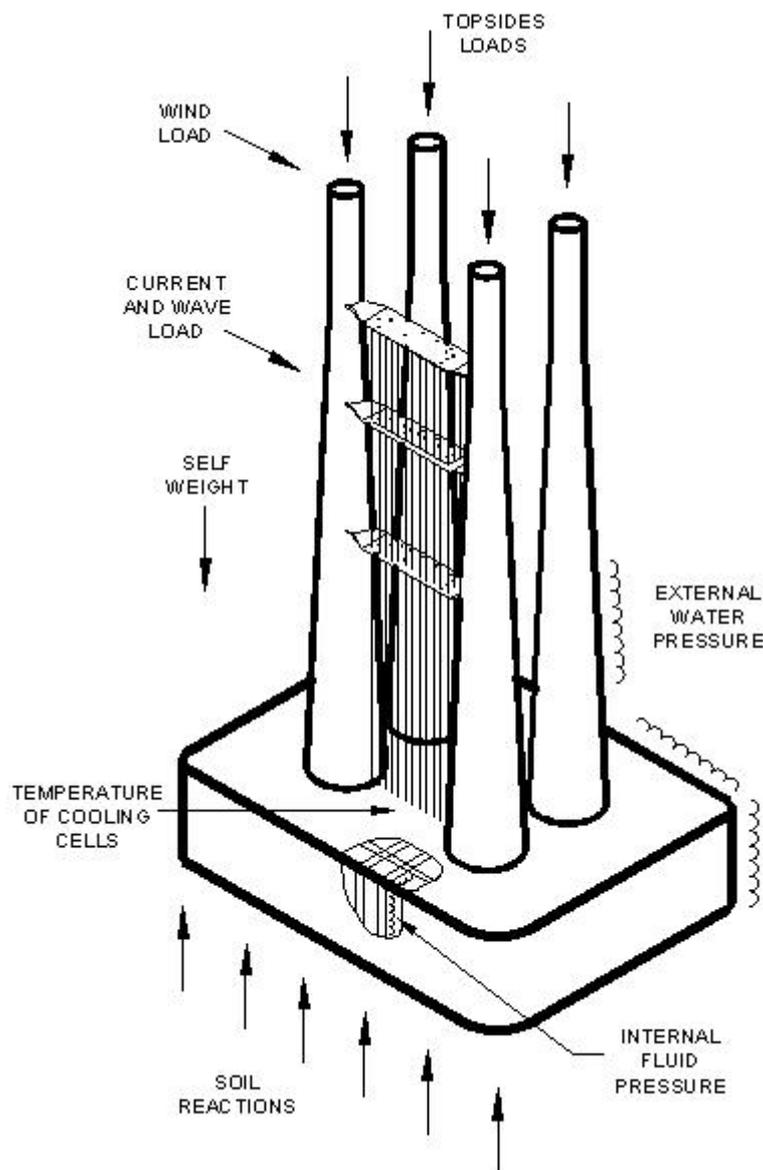
**Figure 2 : Dunlin A Substructure**

A general arrangement of the Dunlin A substructure is shown in Figure 2. There are four main legs extending upwards from the CGB base, which support a steel topsides structure. Two of the legs (C and D) are also interconnected by conductor guide frames that reduce the free span of the conductors. The remaining two legs (A and B) contain services.

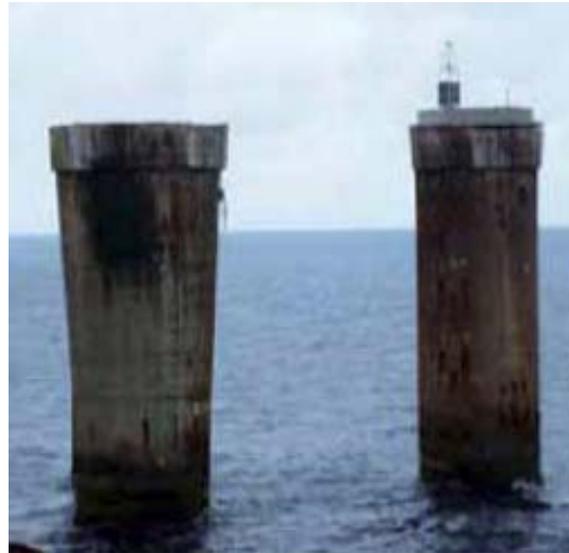
**Figure 3 : East Frigg TCP2 Concrete capped with AtoN Navaid on top**

One possible proprietary navaid device considered, suggested by Fairfield, is the Liaaen Aid to Navigation (AtoN) unit, similar to that installed by operator Total on the decommissioned East Frigg CGB platforms. Details of this equipment are presented in Appendix A. Figure 3 and 4 illustrate the as-left configuration at Frigg.

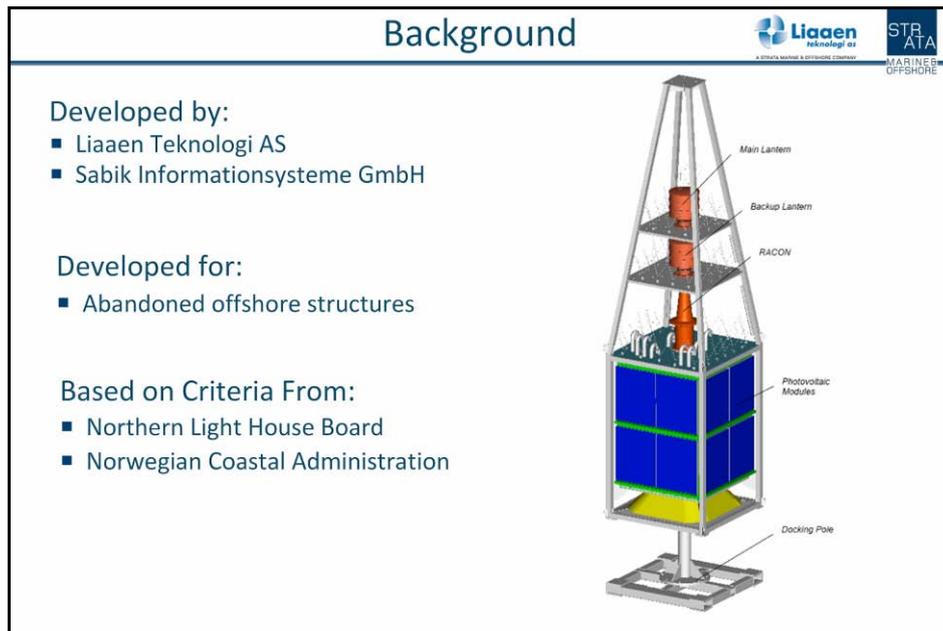
**Figure 5 : Liaaen AtoN navaid unit**

However, since the remaining structure would be surface-piercing, or within 55 m of the surface, it is required by regulations that the CGB be marked by navigation aids such as a Liaaen AtoN navaid unit, similar to that shown in Figure 5.

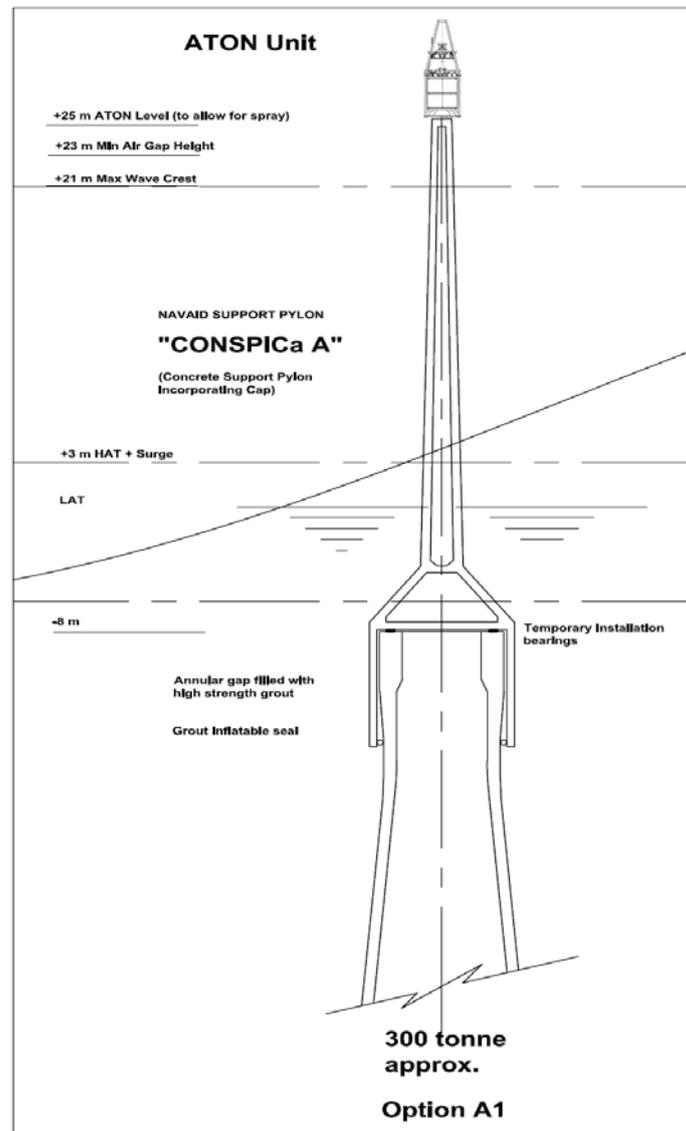
**Figure 6 : Lighthouse Mode Option A1**

**Option A1** (see Figure 6) was the starting point but proved to be too slender for the hydrodynamic loading and dynamic response.

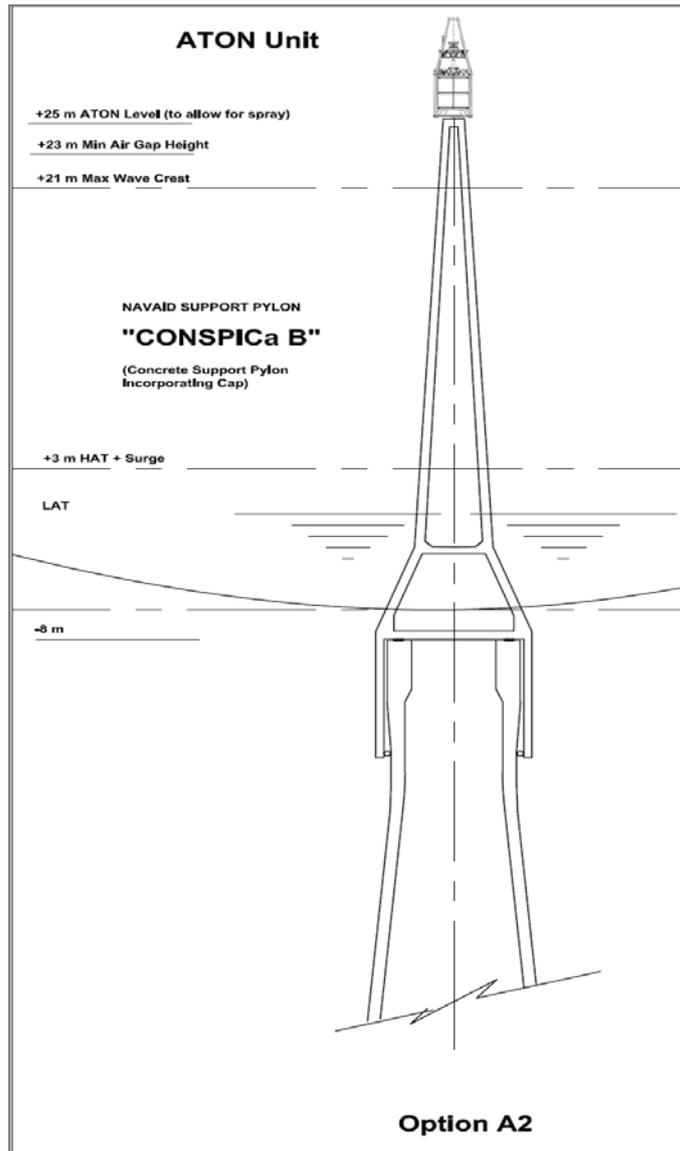
Figure 7 : Lighthouse Mode Option A2

Option A1 was discarded in favour of **Option A2** which proved to be capable of being prestressed with a practical number of tendons to prevent cracking and resultant deterioration (see Figure 7). This scheme comprises a concrete leg integral with a cap that can be grouted over the existing top of shaft ring beam. However, it could only easily be deployed on legs A and B because the other legs have out-of-circular prestressed concrete ring beams for the conductor framing, which would prevent easy installation of the "overshot" connection. This may limit life expectancy, as legs A and B are not as strong as legs C and D.

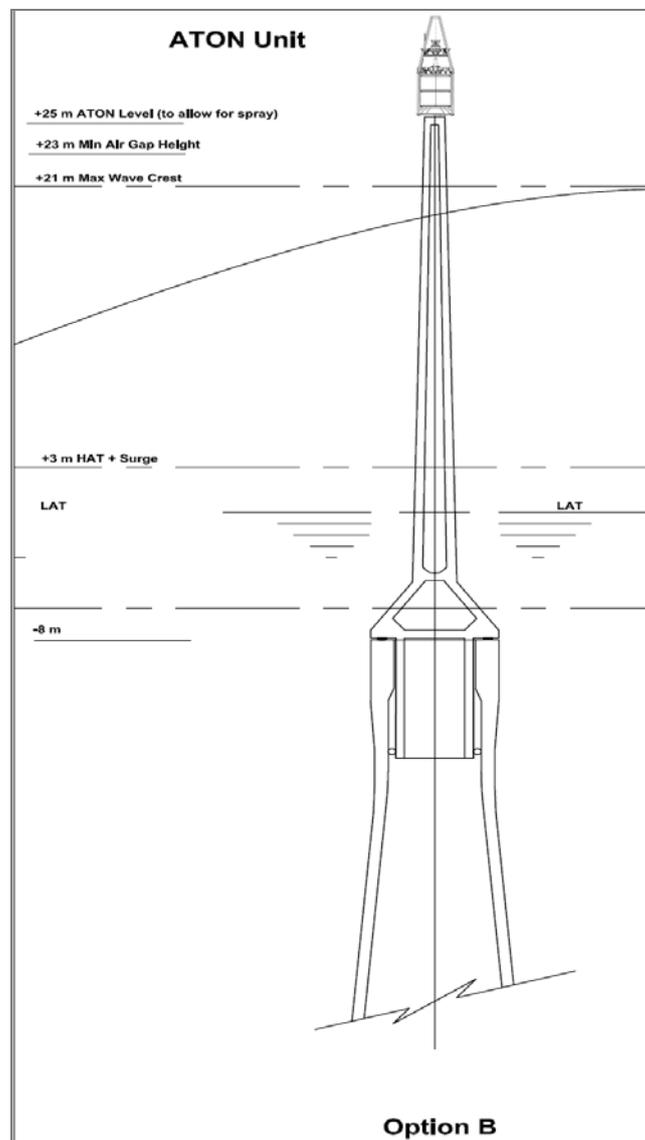
**Figure 8 : Lighthouse Mode Option B**

**Option B** is a variant of Option A2 (see Figure 8) with the lower section being inserted into the top of the shaft and grouted within it, as opposed to the cap detail. It is not considered to be as durable a structural solution as the “overshot” A2 connection detail, as it has a smaller diameter at the interface and does not prevent long term wave erosion at the externally exposed (grouted) joint. However, it would permit the navaid support to be installed more readily on any leg, and installation of legs C and D would improve the life expectancy of the structure, due to their increased capacity to carry additional wave load.

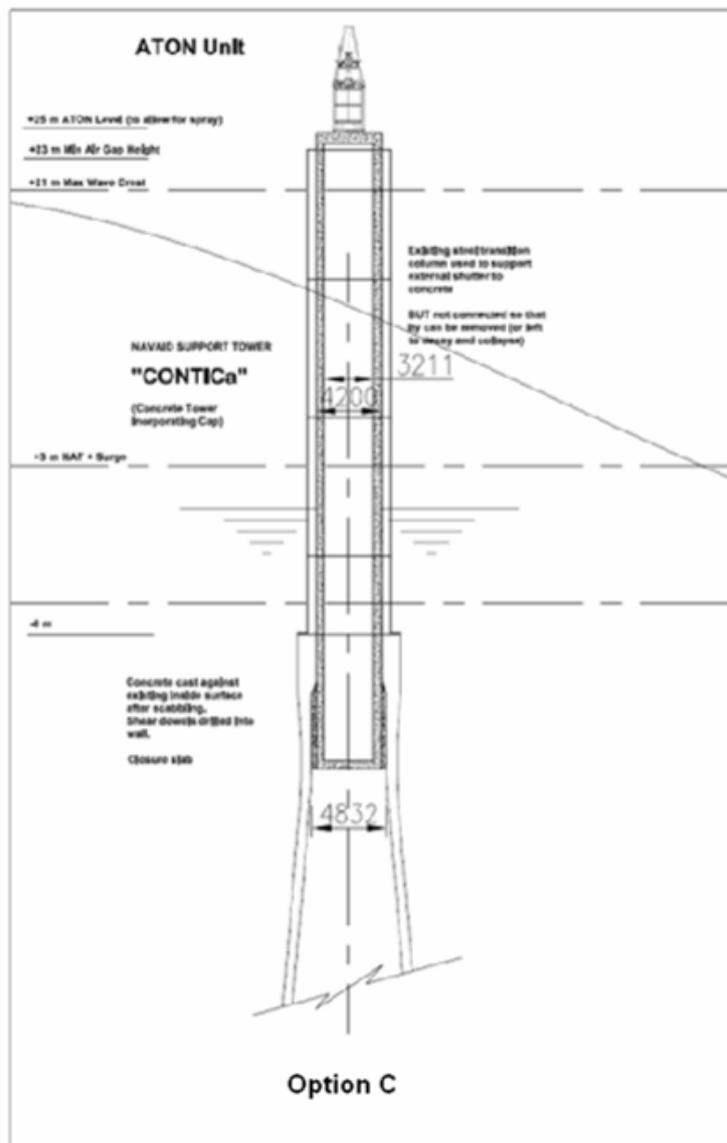
**Figure 9: Lighthouse Mode Option C**

**Option C** was conceived as a solution which could possibly be constructed internally within the steel column, using this to provide a dry environment and to support the concrete or its formwork during pouring (see Figure 9). This would avoid the need for a heavy lift installation of a pre-cast unit such as A2 and would avoid the complication of a subsea grouted connection. It could be constructed in advance of deck removal and would not require the column to be cut off subsea. The steel that surrounds the concrete leg would be left to degrade with time, supported by the concrete leg within. There are therefore several benefits to this option, but the drawback is the cost of significant offshore operations. It would have larger wave loading than Option B and therefore be not as strong.

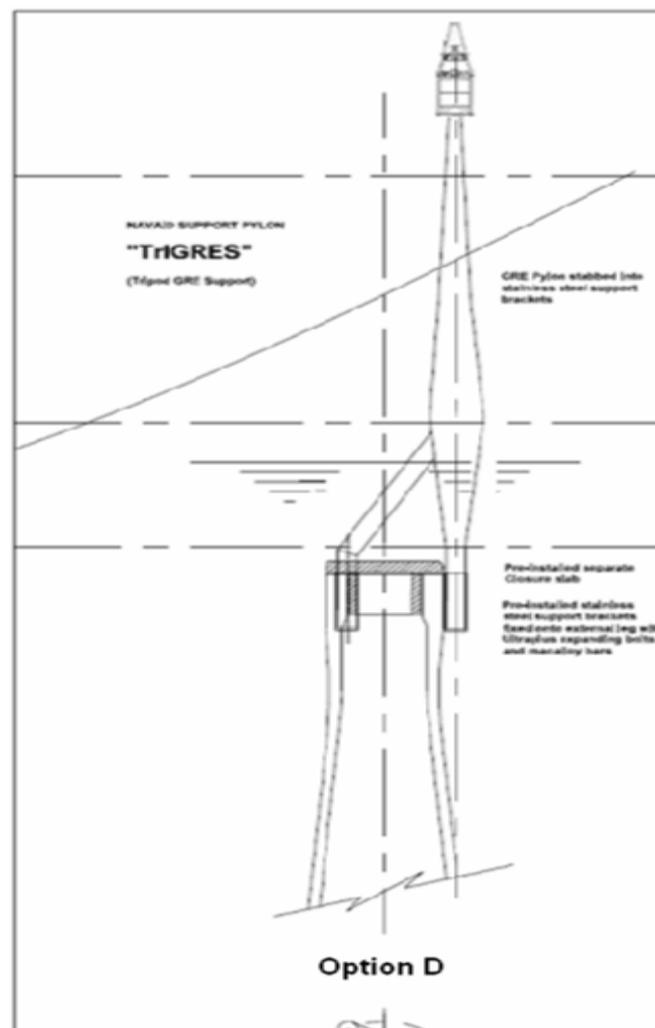
**Figure 10 : Lighthouse Mode Option D**

**Option D** was conceived as a “concrete jacket” or braced flagpole stabbed into concrete or stainless steel socket piles bolted and stressed onto the external wall of the leg (see Figure 10). On top of this a variant of Option A2 would be stabbed and grouted. This is an inelegant and structurally inefficient solution and was rejected from any further development or costing. However, a variant of this, a propped ‘flagpole’, is considered feasible. A tripod base structure was envisaged, connected to the prestressed upper ring beam on either of legs C and D, possibly using the existing conductor framing anchorages. The chief disadvantage of any of these structures is the material selection, as concrete is not good for this type of frame structure and stainless steel and GRE are costly or of poor life expectancy.

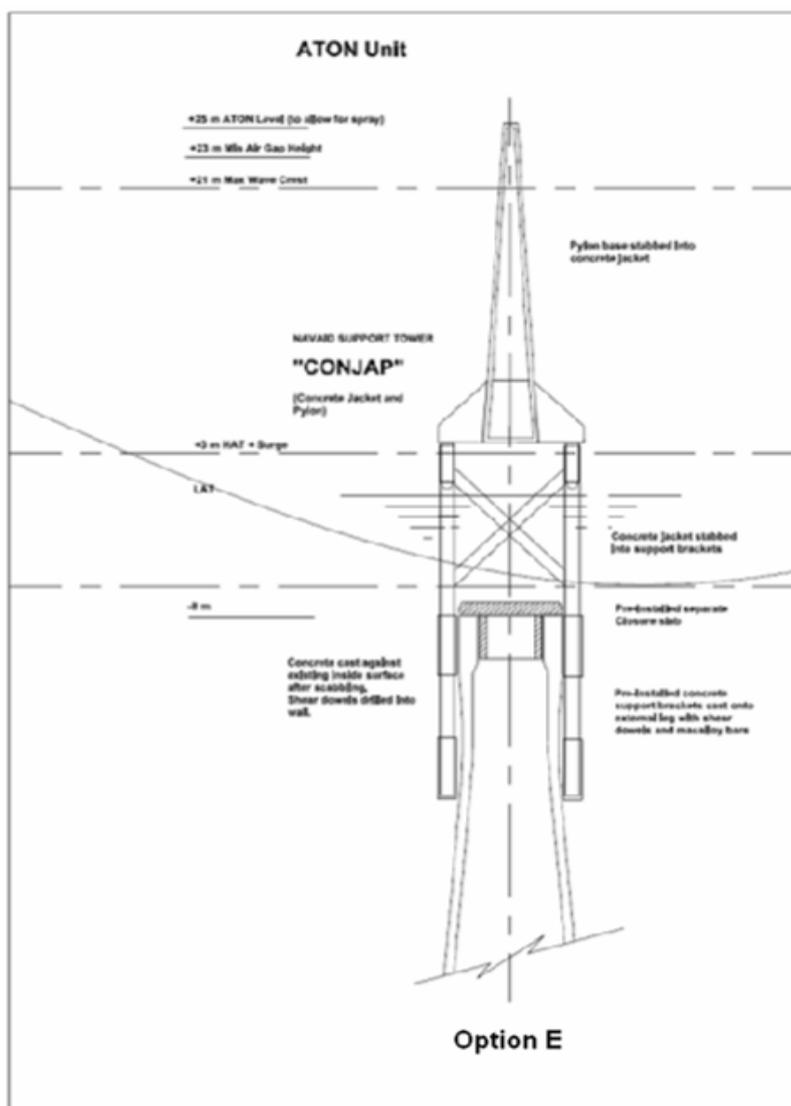
Figure 11: Lighthouse Mode Option E

**Option E** is a variant of Option A2 with the modification that its lower section is sized to encompass the bottom half of the steel column (see Figure 11). This would allow the steel column to be removed down to the level of the highest astronomical tide (or possibly lower) without the need for underwater operations. The lower portion of the steel column would then be encapsulated within the concrete lighthouse structure. It would not form part of the structural system, but would be protected by the concrete around it. The advantage here is the lack of subsea cutting, but the disadvantage is a larger and heavier navaid column that would be more difficult to install, particularly over the conical steel columns on legs C and D.

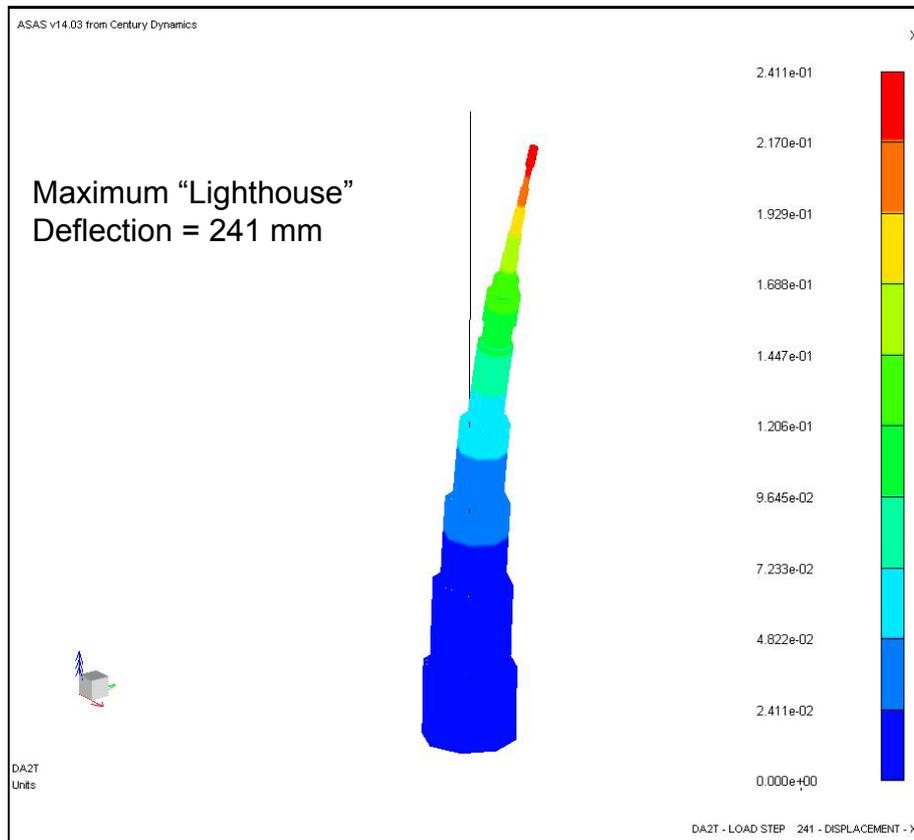
**Figure 13: Displacement of Dunlin Leg in 100-year Storm Conditions**
