# Dunlin Alpha Decommissioning

**Concrete Gravity Base  
In Situ Decommissioning  
Options for Derogation  
November 2011**

## In Situ Decommissioning Options for Derogation

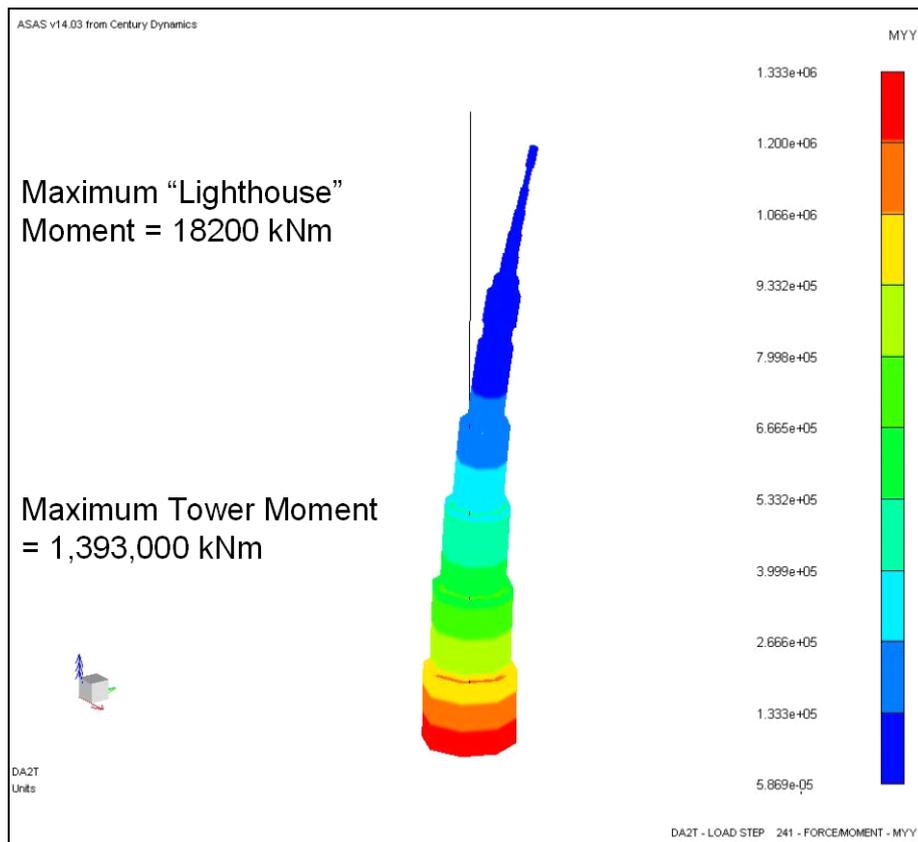
**Figure 14 : Moments along Dunlin Leg under 100-year Storm Conditions**

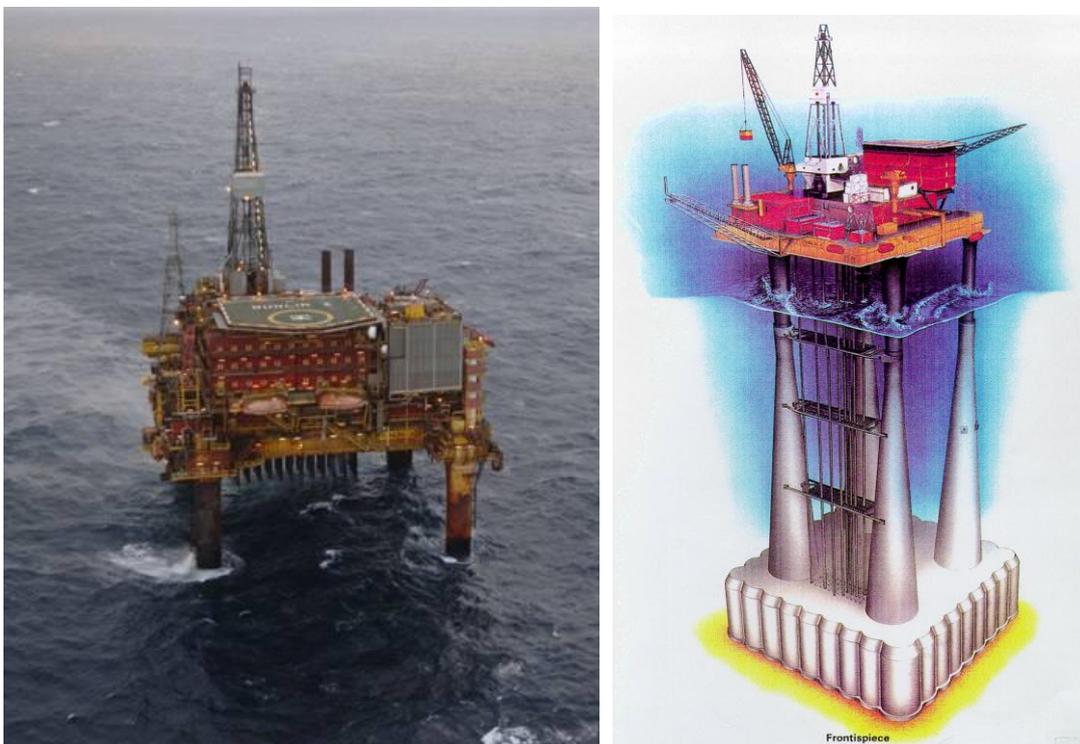
Figure 1-1 Dunlin Alpha Platform

Fairfield Energy is operator of the Dunlin Cluster of fields in the North Sea, which includes the Dunlin Alpha platform (Figure 1-1). Dunlin Alpha consists of a concrete gravity base supporting a steel topsides.

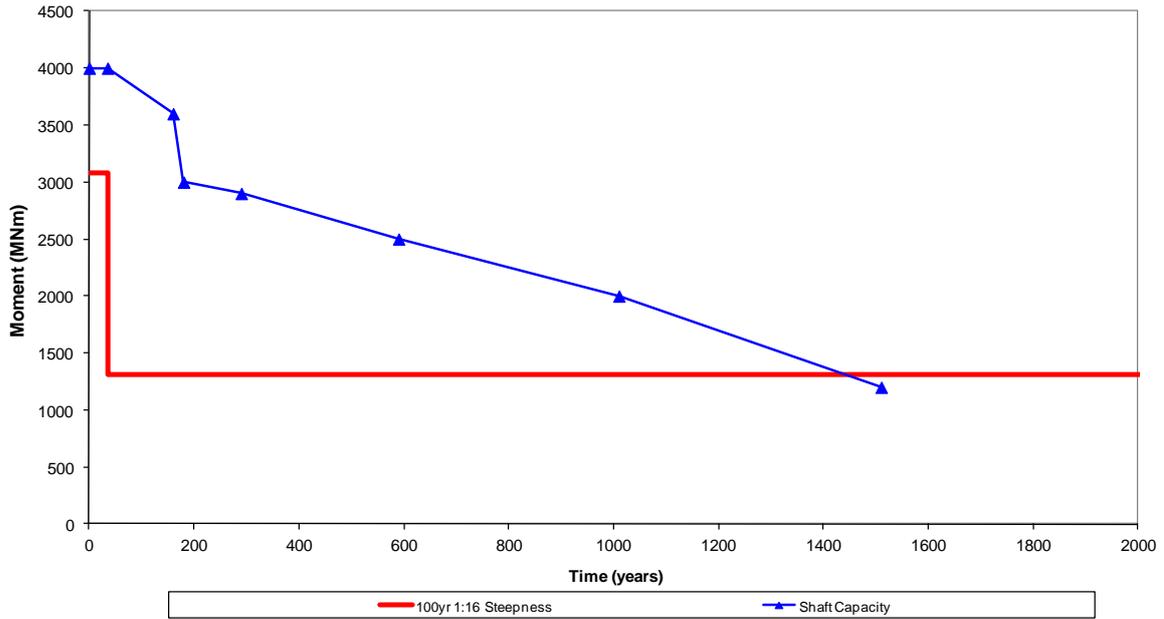
Figure 5-1 Base of leg capacity versus time – Grade C55 concrete

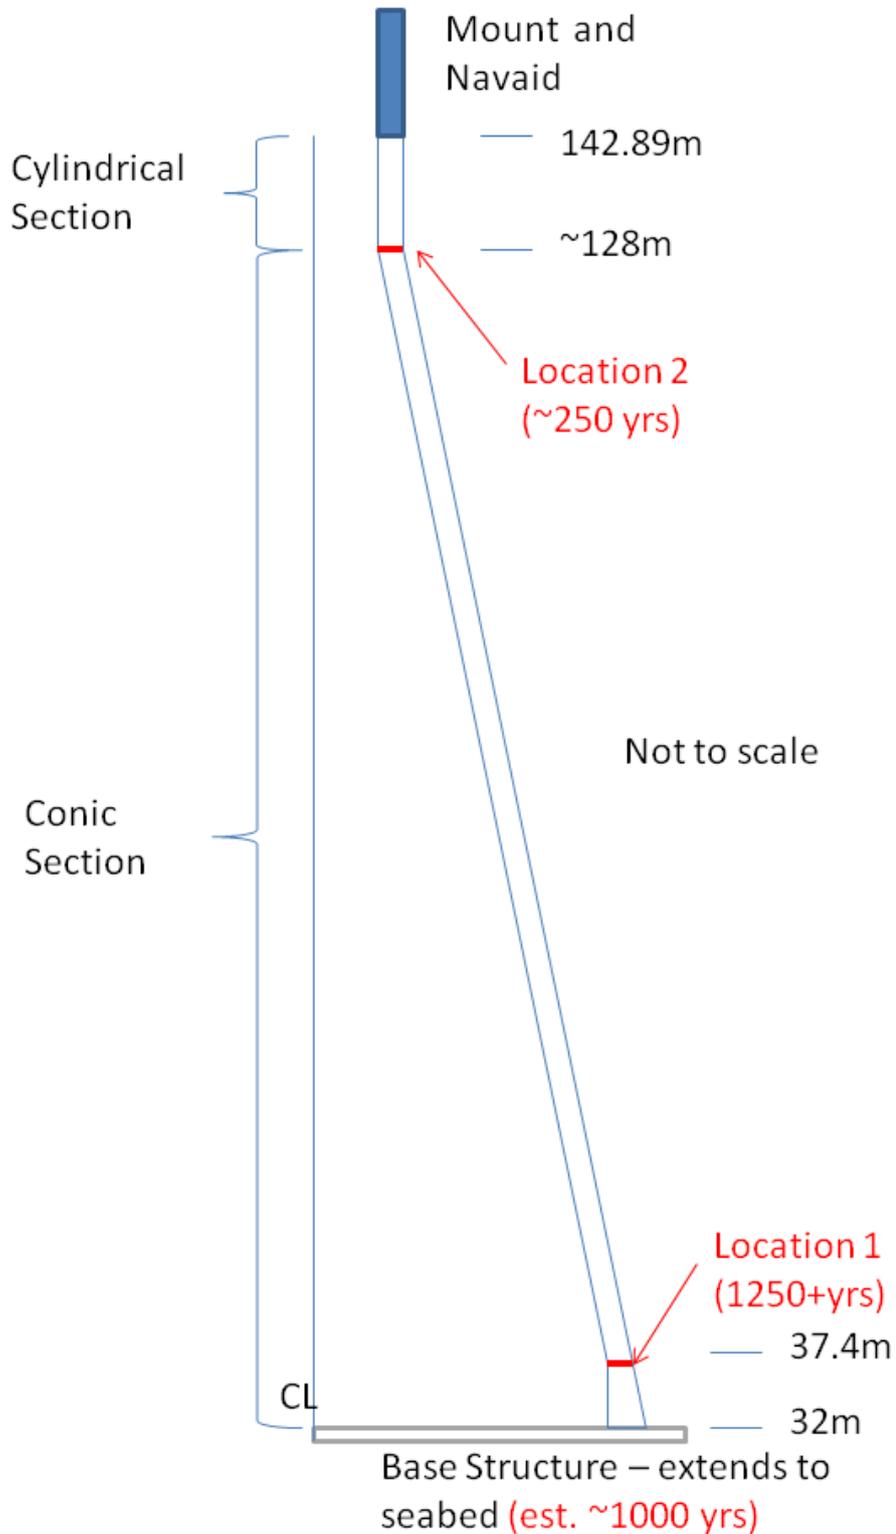
Figure 5-3 Concrete leg locations and predicted time to failure

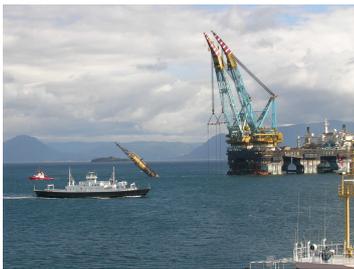
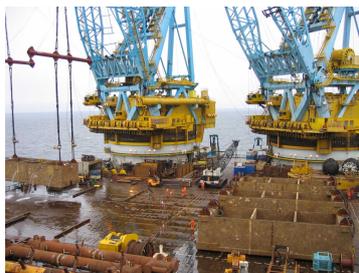
## Brent Flare & SPAR Anchor Blocks

In August 2005 Shell recovered the Brent Flare and SPAR Anchor Block structures from the Brent Field. The contractor was Saipem using the HLV S7000. The methods used were derived from studies carried out by Atkins for Shell in 2003, 2004 and 2005.

The Anchor blocks were identified as having real residual civil engineering value and were taken to Norway where they are to be used in the construction of a new decommissioning quay.
